**Resurrection Creek Stream Restoration Project
End of Construction Season Progress Report
September 2005**

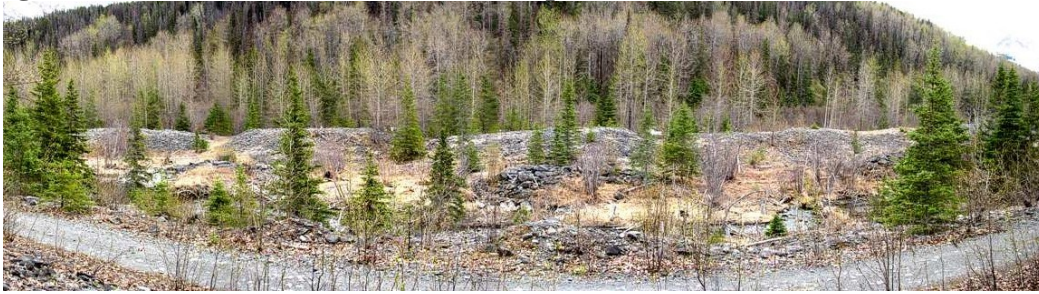
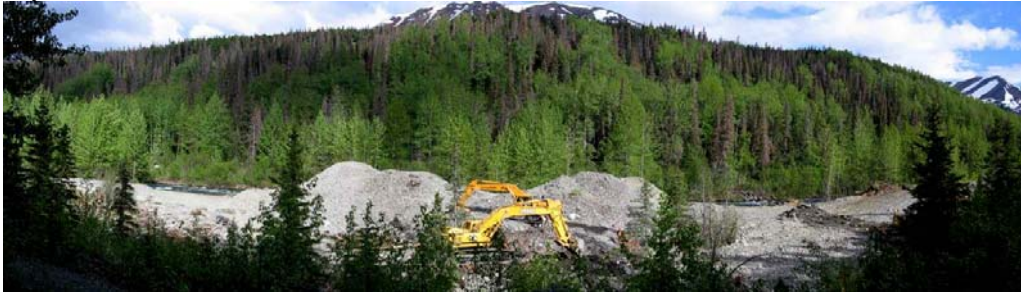
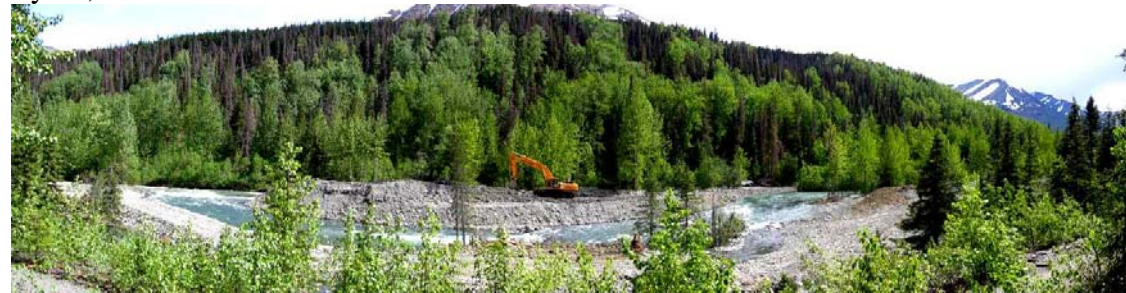
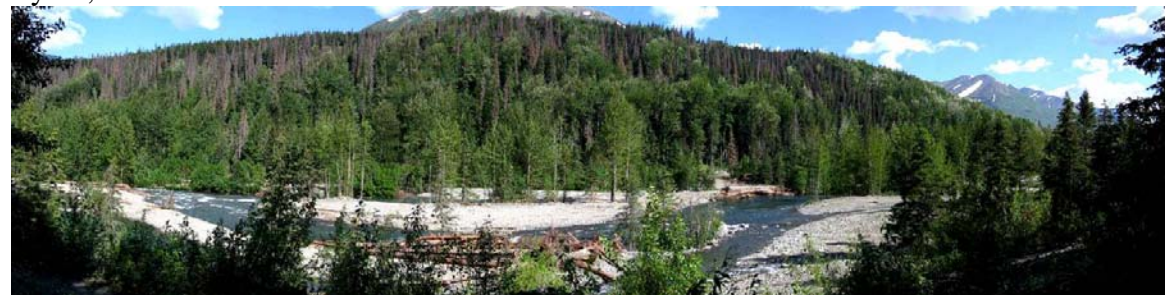
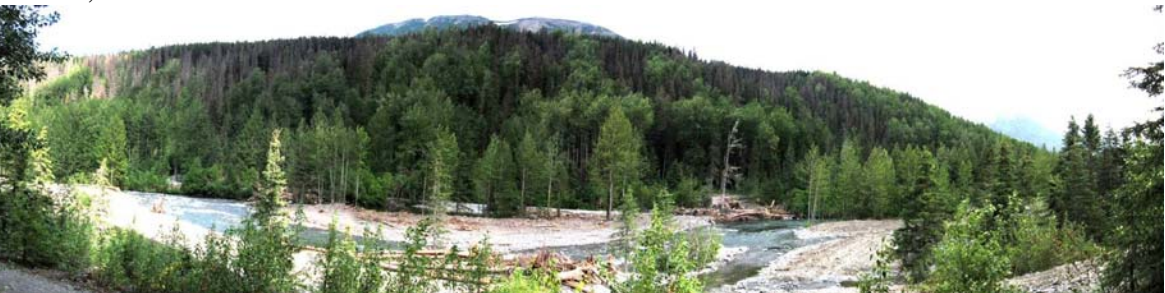
Figure 3 - “Meander 3” Construction Sequence (from the Resurrection Pass Trail)

Figures 3 and 4 show parts of the construction sequence for Meanders 3 and 5. On each constructed meander, the channel was excavated in the dry. Using cross-channel ribs, riffles, pools, and glide segments were formed. Coarse channel substrate was laid in on riffle segments. When channel formation was completed, streamflows were diverted into the meander, and both tailings piles and excavated materials were pushed into the pre-existing channel. Floodplains and side sloughs were developed on both sides of the new channel. Floodplains were covered with soil and woody debris. Meander 5 was the last new meander completed in 2005.

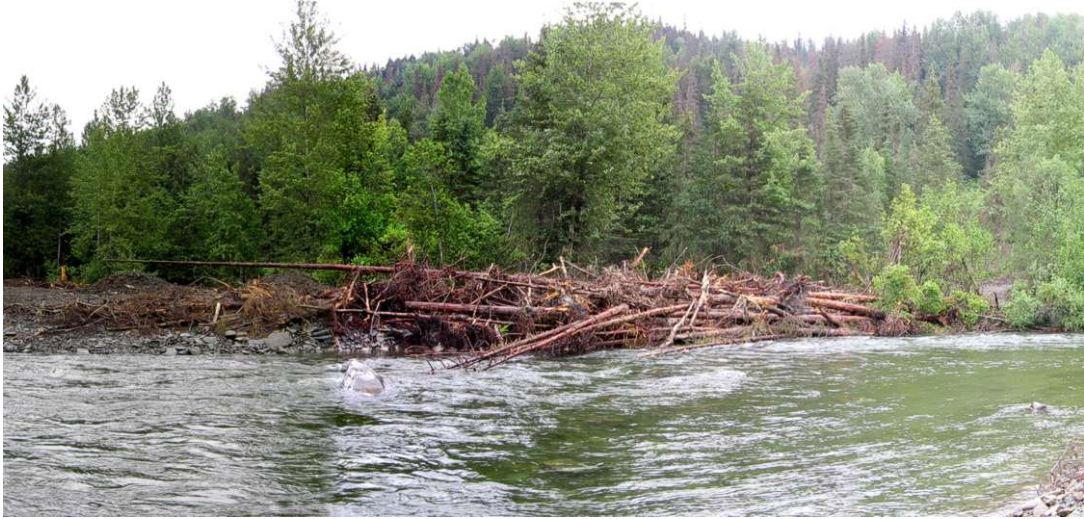
Figure 5- Engineered Log Jam at the Upper End of “Meander 3”

Figure 5 shows a log jam built on Meander 3. This is one of 10 log jams constructed on the project. These jams are engineered and "keyed" deeply into the streambank making them largely resistant to flood impacts. The log jams work to collect additional woody debris, provide cover and nutrients to rearing fish, and on this project have been frequently used at the head of side sloughs to moderate flood flow volumes into the side slough while still allowing water flow during winter low flow conditions.

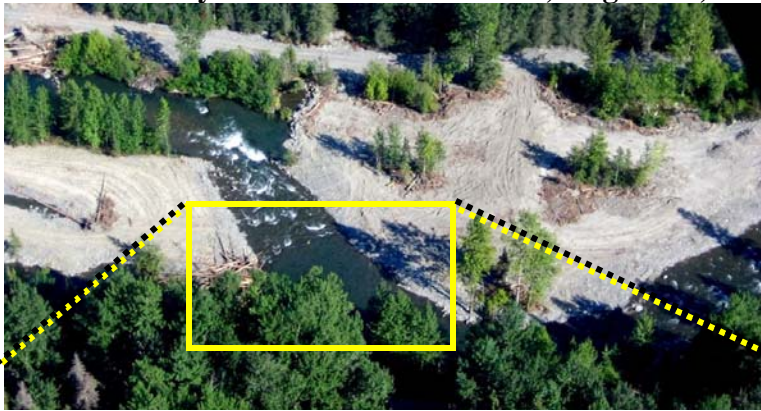
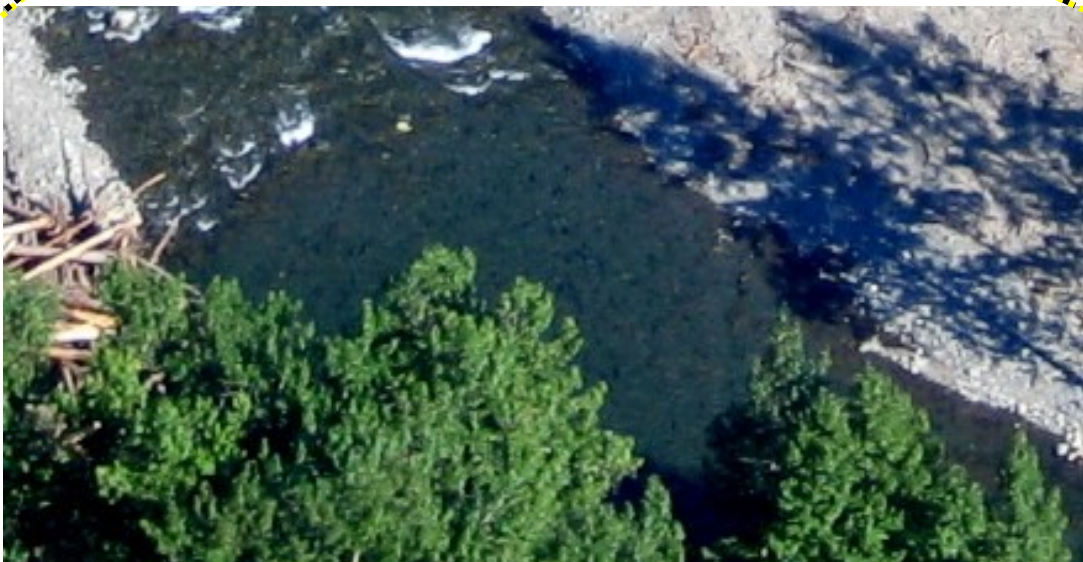
Figure 6 – Some of the over 1,000 Pink Salmon Spawning on the Newly Restored Stream Reach, August 11, 2005

Figure 6 shows an 8/11/05 aerial photograph of one segment of newly reconstructed stream channel with over 100 pink salmon spawning in it. We counted over 1,000 pink salmon in the newly restored channel. This is an "off" year for Cook Inlet pinks. Larger numbers of pink spawners are likely to return in even years. In July we counted over 100 chinook salmon spawners in the restored reach, and by early September, over 100 coho spawners.
